FUSION NEUTRON TRANSIENT EFFECTS TO CHARGE COUPLED DEVICE CAMERA IMAGES

Michael S. Giauque

June 1999

MASTER OF SCIENCE IN APPLIED PHYSICS

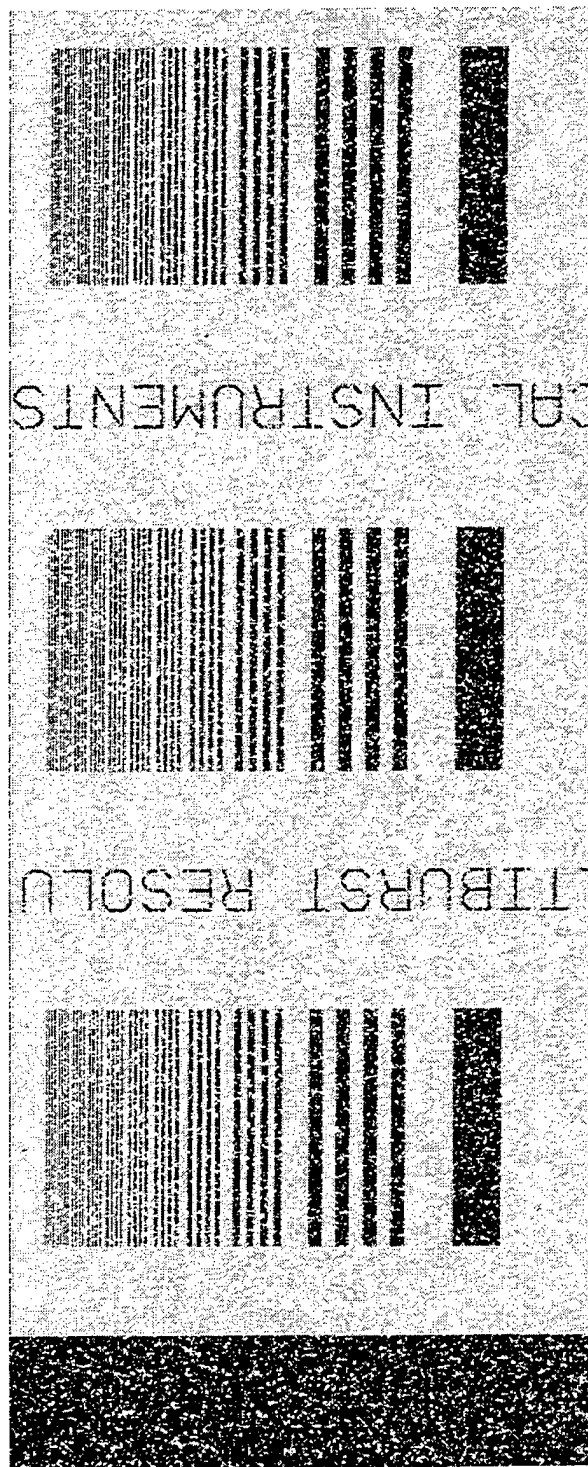
Figure 10. Image with fluence corresponding to $9.92 \times 10^8 \text{ n/cm}^2$.

This research confirms that CCD cameras will need to be shielded from 14MeV neutron irradiation in order for this device to be used as a diagnostic tool for fusion events at NIF. The simulated images (Figures 9, 10 and 11) show that fluences above 10^8 n/cm² seriously degrade the visual quality of images. Neutron fluence on the order of 10^{12} or 10^{13} n/cm², as would be found inside the target chamber at ranges less than 5 meters during a 21 MJ shot (Table 1), would render the image unusable.

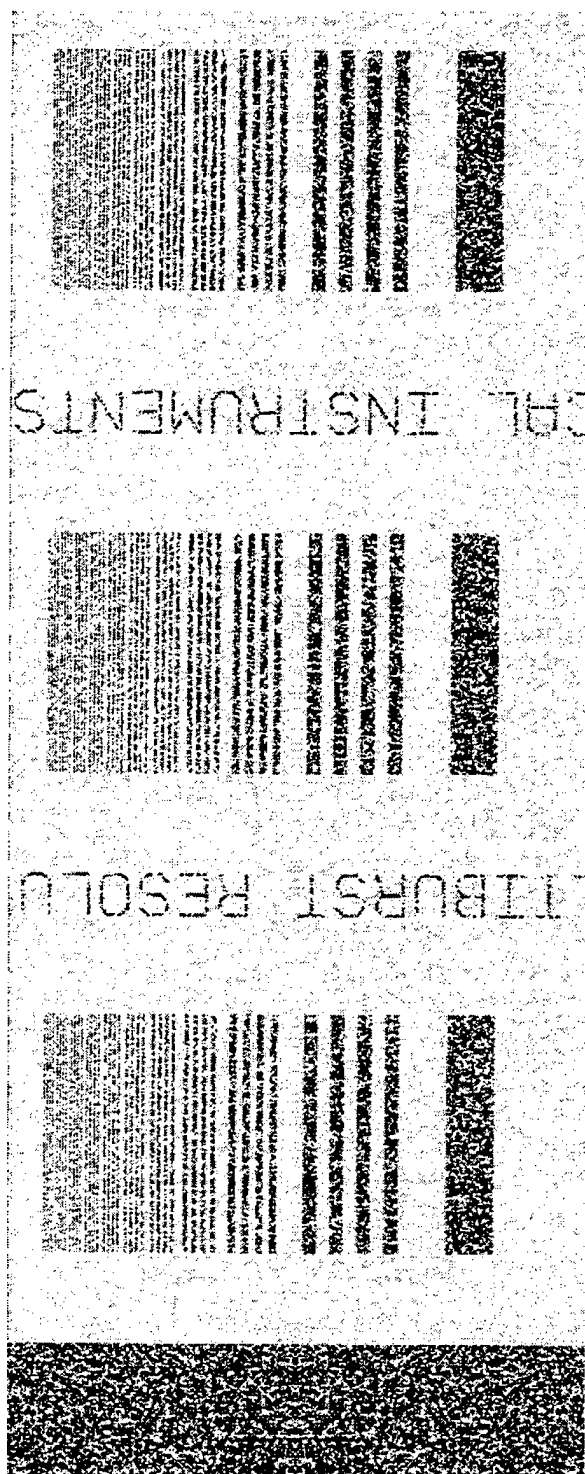
Figure 11. Image with fluence corresponding to $1.98 \times 10^9 \text{ n/cm}^2$.
